JATIONAL REGISTER OF HISTORIC PLACES INVENTORY -- NOMINATION FORM

Locust Hill, located in a rural farming area in the rolling hills overlooking the Missouri River flood plain, is an estate which includes a residence, garage, privy, root cellar, shed, smokehouse, summer kitchen, chicken yard, two garden areas, a large yard and some surrounding land. (see site plan).

LOCUST HILL

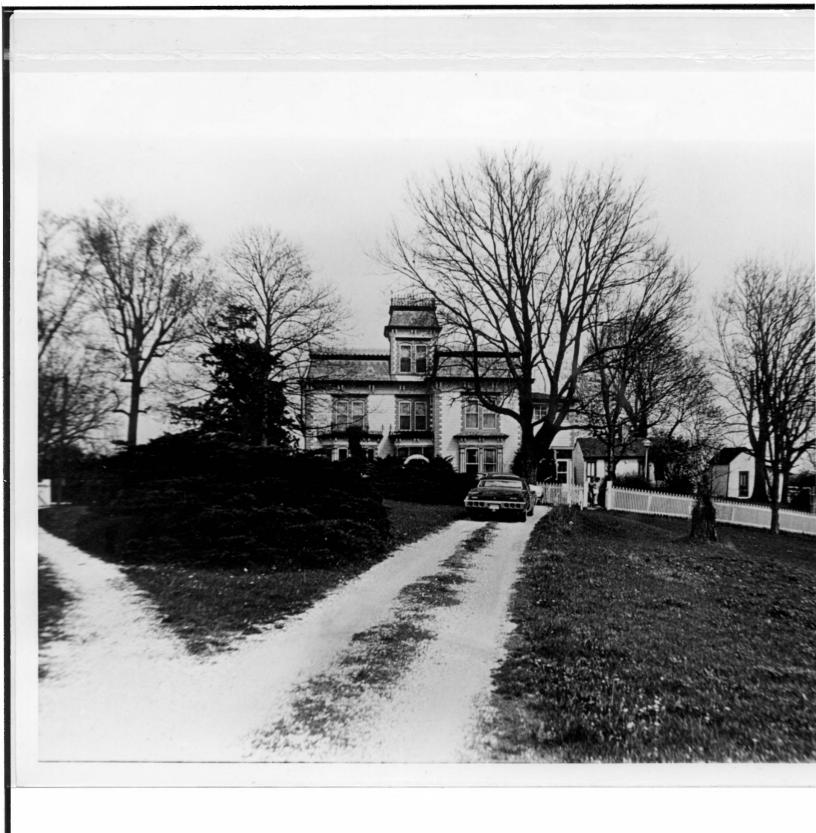
LOCUST HILL #1
Highway Y, Box 106, Brunswick, Chariton County,
Missouri
Photographer: Booker H. Rucker

Department of Natural Resources, P.O. Box 176, Jefferson City, Mo. 65102 General view to east of house and outbuildings.

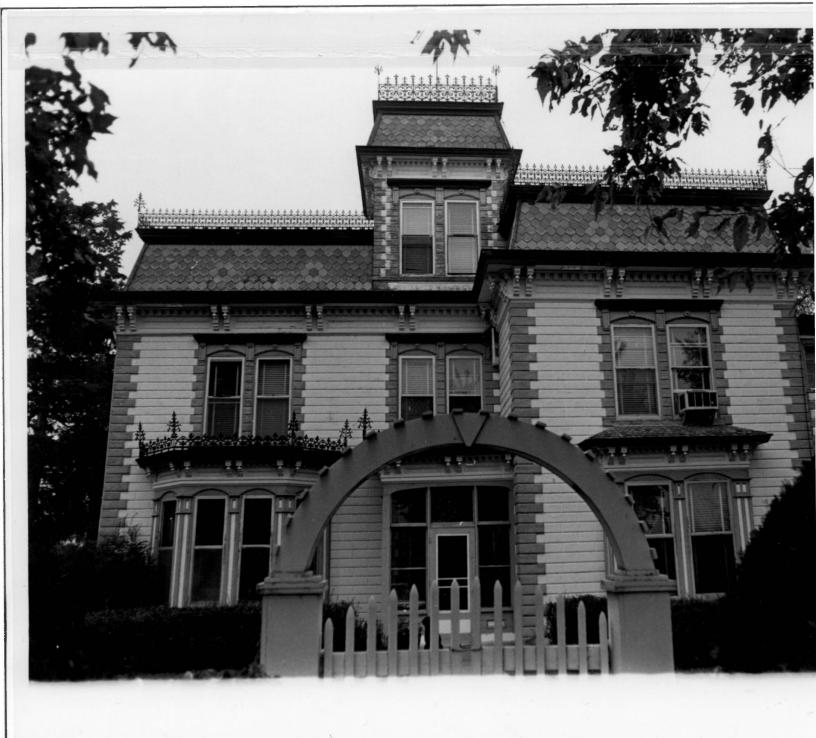
LOCUST HILL #2
Highway Y, Box 106, Brunswick, Chariton County,
Missouri
Photographer: Noelle Soren
October, 1979
Department of Natural Resources, P.O. Box 176,
Jefferson City, Mo. 65102
West (primary) facade.

The main house at Locust Hill is a two story Second Empire style building which is of frame construction over stone and concrete foundations. It is capped with a mansard roof which is faced below with red, green, grey and black hexagonal slates and above with composition material. A partial basement is located beneath the kitchen addition to the east. The exterior of the house is faced with pine boards, grooved to imitate rusticated masonry, which were originally sand painted but which are now overpainted in white. The wooden quoins and bracketed Mannerist-inspired window surrounds and other details are highlighted in rose beige. Other notable decorative features include heavy brackets with pendants and a denticulated and paneled frieze, both at cornice level, a mansarded cupola over the main entrance and elaborate cresting in at least four distinct patterns.

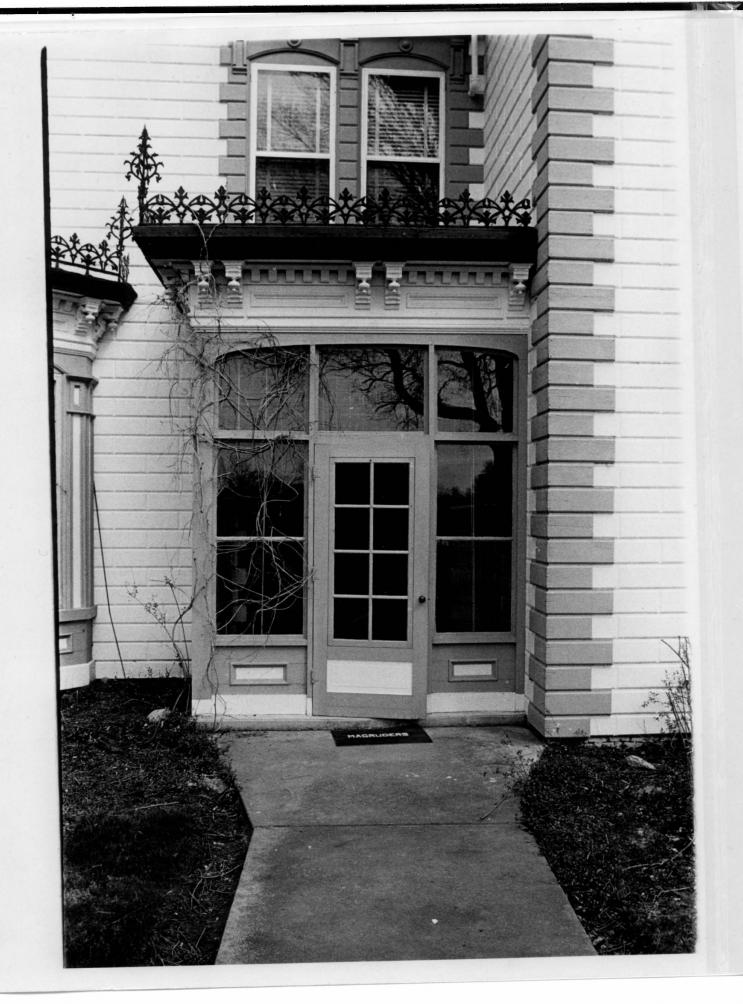
LOCUST HILL
Highway Y, Box 106, Brunswick, Chariton County,
Missouri
Photographer: Booker H. Rucker
Spring, 1973 (condition remains the same)
Department of Natural Resources, P.O. Box 176,
Jefferson City, Mo. 65102
West (primary) facade, detail of main entrance.

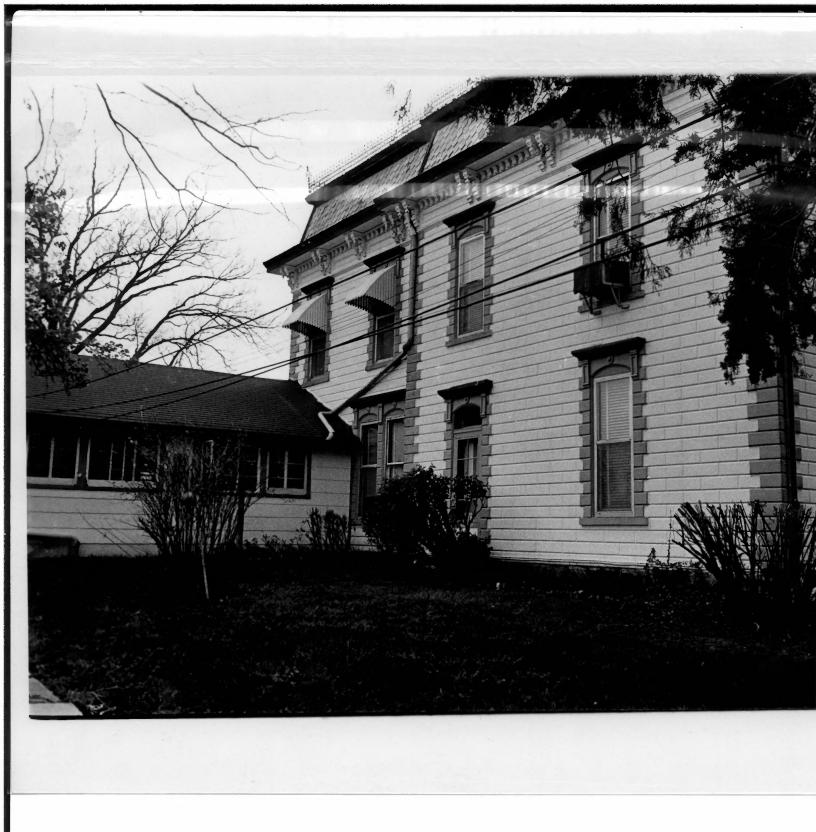
LOCUST HILL #4
Highway Y, Box 106, Brunswick, Chariton County,
Missouri
Photographer: Booker H. Rucker
Spring, 1973 (condition remains the same)

Department of Natural Resources, P.O. Box 176, Jefferson City, Mo. 65102
East (rear) side of house, view to southwest, with modern kitchen addition to the left.

Two modern additions are associated with the house, a two story porch and upper room on the south side and a one story kitchen on the east. The style of the interior woodwork and fixtures of the latter indicate a date of construction in the decade of the 1940's. The date of the former addition is unknown. This section, which includes a glassed-in porch, is faced on the primary facade with rusticated boards removed from the wall which was abolished by the addition.

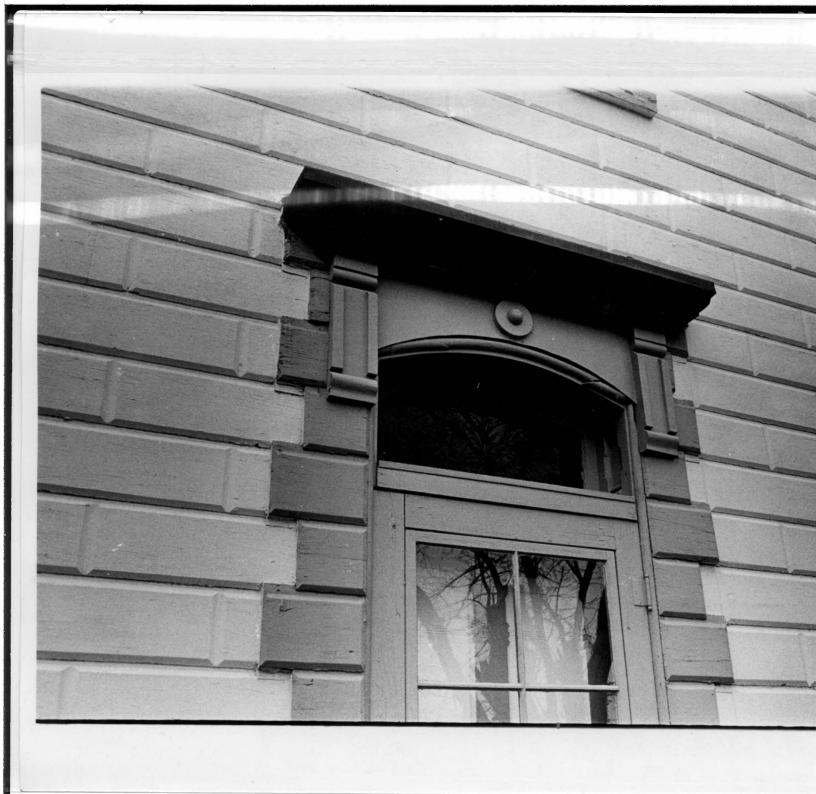
Jefferson City, Mo. 65102 East (rear) entrance, detail of woodwork.

The interior of Locust Hill features wall papers imported from France in the parlors, pine woodwork embellished in all the rooms with several variations of incised Eastlake inspired designs, and an elaborate open stairway with spiral balusters and an octagonal newel. When the house was electrified, all of the original gas, kerosene and oil fixtures were adapted for the new medium. In addition, the original furnishings belonging to the Herring and Magruder families remain in the house. (Rucker, pp. 4-10 and Richardson, personal interview).

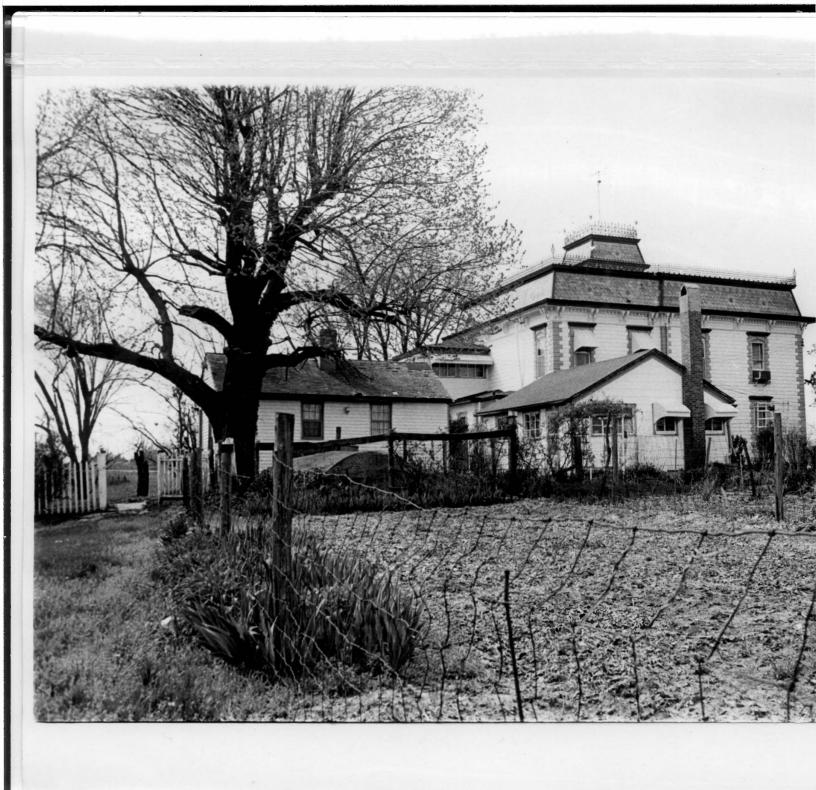
LOCUST HILL #6 Highway Y, Box 106, Brunswick, Chariton County, Missouri Booker H. Rucker Spring, 1973 (condition remains Photographer:

Department of Natural Resources, P.O. Box 176, Jefferson City, Mo. 65102 View to northwest of rear of house showing the summer kitchen to the left and the newer kitchen addition in the center.

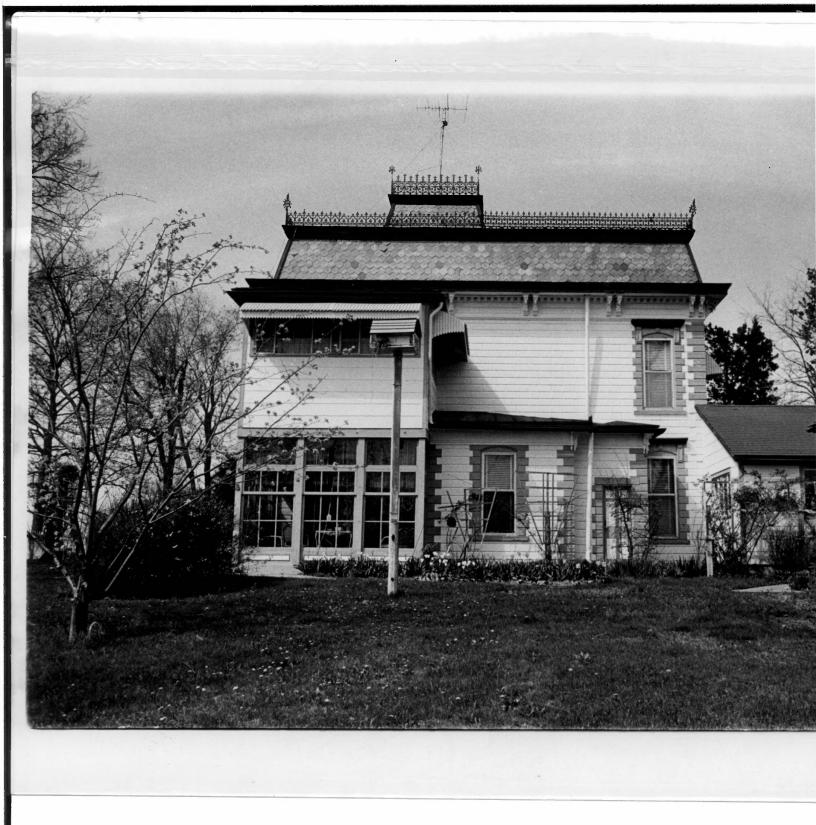
Jefferson City, Mo. 65102 South side of house, summer kitchen and newer kitchen addition to the right.

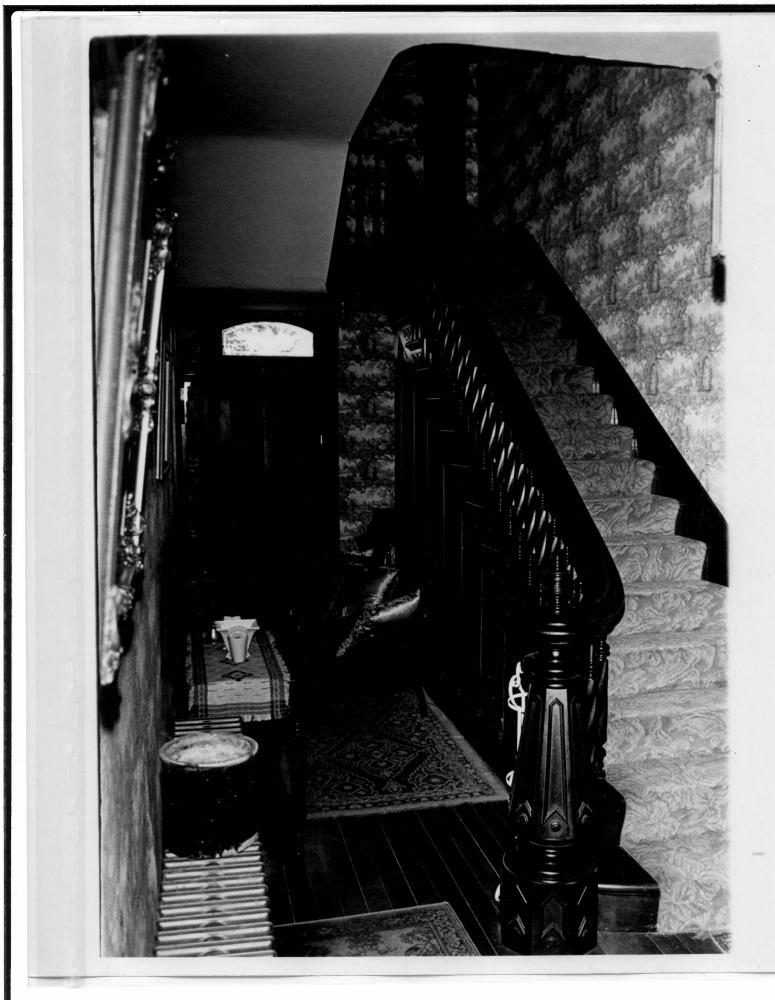
LOCUST HILL #10 Highway Y, Box 106; Brunswick, Chariton County, Missouri

Interior, central hallway with staircase,

view to east.

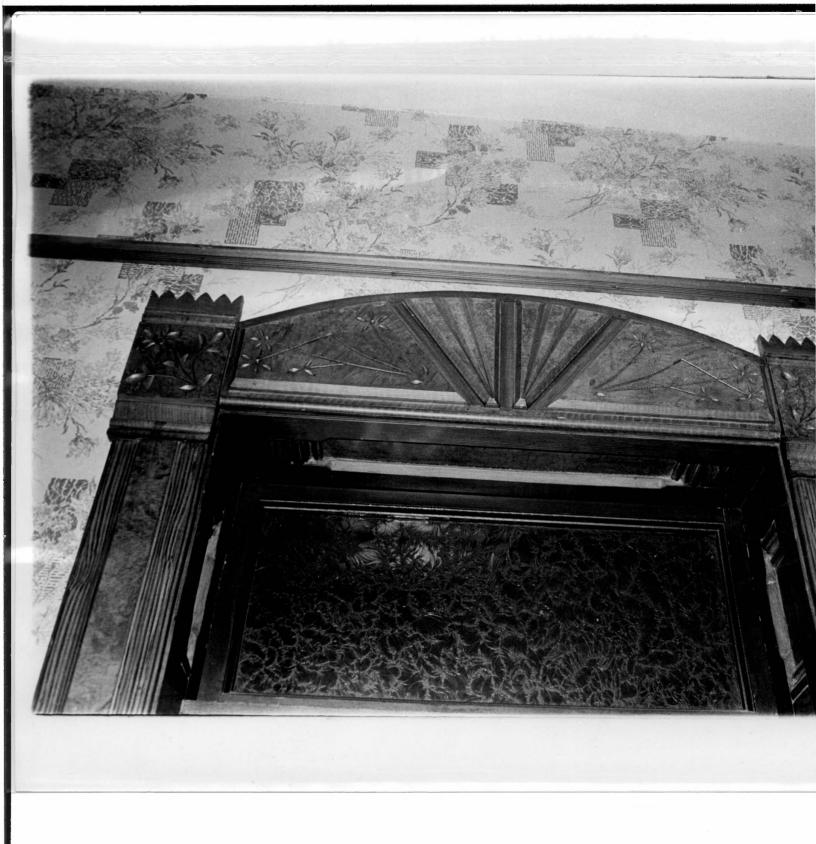
LOCUST HILL
Highway Y, Box 106, Brunswick, Chariton County,
Missouri
Photographer: Booker H. Rucker
Spring, 1973 (condition remains the same)
Department of Natural Resources, P.O. Box 176,
Jefferson City, Mo. 65102
Transom and woodwork over doorway linking dining room and later kitchen addition.
